Manhole Inspection Summary

Manhole # S07OO1027MH

Insp Date: **5/14/07 3:32 PM**

Location Address: **NEXT TO 5103 IN ALLEY OFF
BEAUFORT**

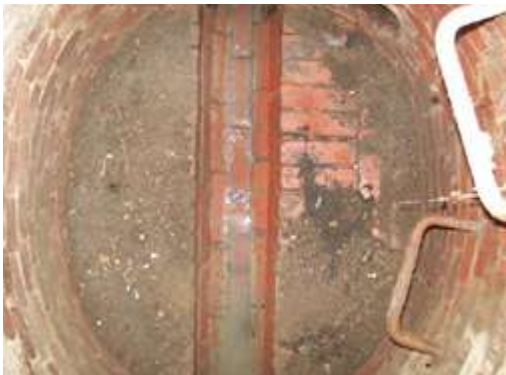
Defect 1

Count: **2** Missing: **0** ☒ **Corroded**

CORRODED STEPS

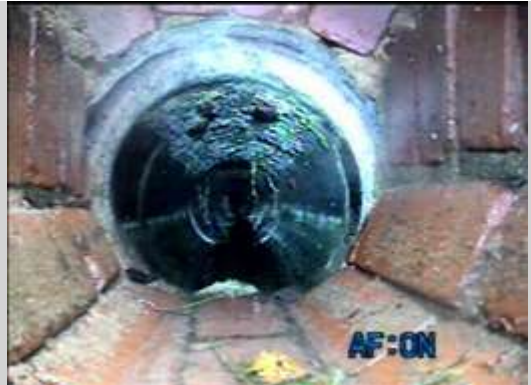
12 O'Clock Outflow

8 in. Circular Gravity Sewer
Pipe Out @ 12 O'Clock

Pipe Height: (in.) Direct
Pipe Material: **Clay** ☐ Pipe Lined
Invert Depth: **5.10** (ft.) Flow Characteristics: **Slow**
Deposits: ☒ None ☐ Mud ☐ Sludge ☐ Debris ☐ Grease
Silt Depth: (in.) Deposits Extent:
Infiltration: **None** Pipe Seal Cond: **Sound**

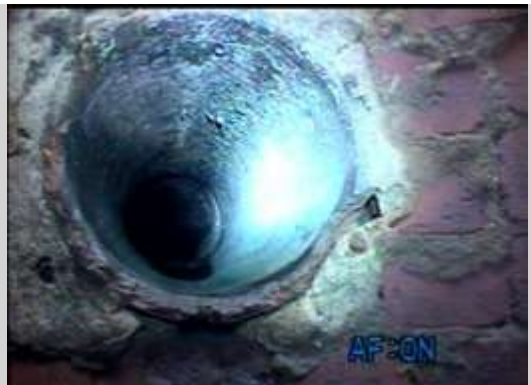
1 O'Clock Outflow

8 in. Circular Gravity Sewer
Pipe Out @ 1 O'Clock

Pipe Height: (in.) Direct
Pipe Material: **Clay** ☐ Pipe Lined
Invert Depth: **3.97** (ft.) Flow Characteristics: **None**
Deposits: ☒ None ☐ Mud ☐ Sludge ☐ Debris ☐ Grease
Silt Depth: (in.) Deposits Extent:
Infiltration: **None** Pipe Seal Cond: **Sound**

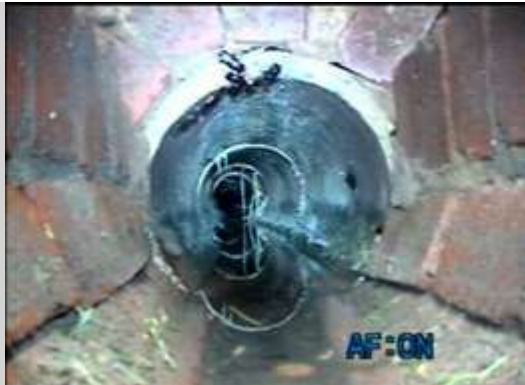
6 O'Clock Inflow

8 in. Circular Gravity Sewer
Pipe In @ 6 O'Clock

Infiltration: **None** Pipe Seal Cond: **Sound**
